Why you must Flush your Power Steering System Prior to Installing New Components.

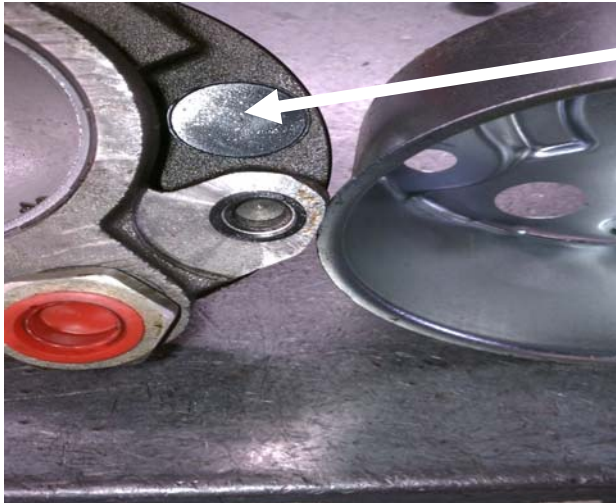
Pump Housing before reservoir installed. Note Magnet on housing to catch metal particles.

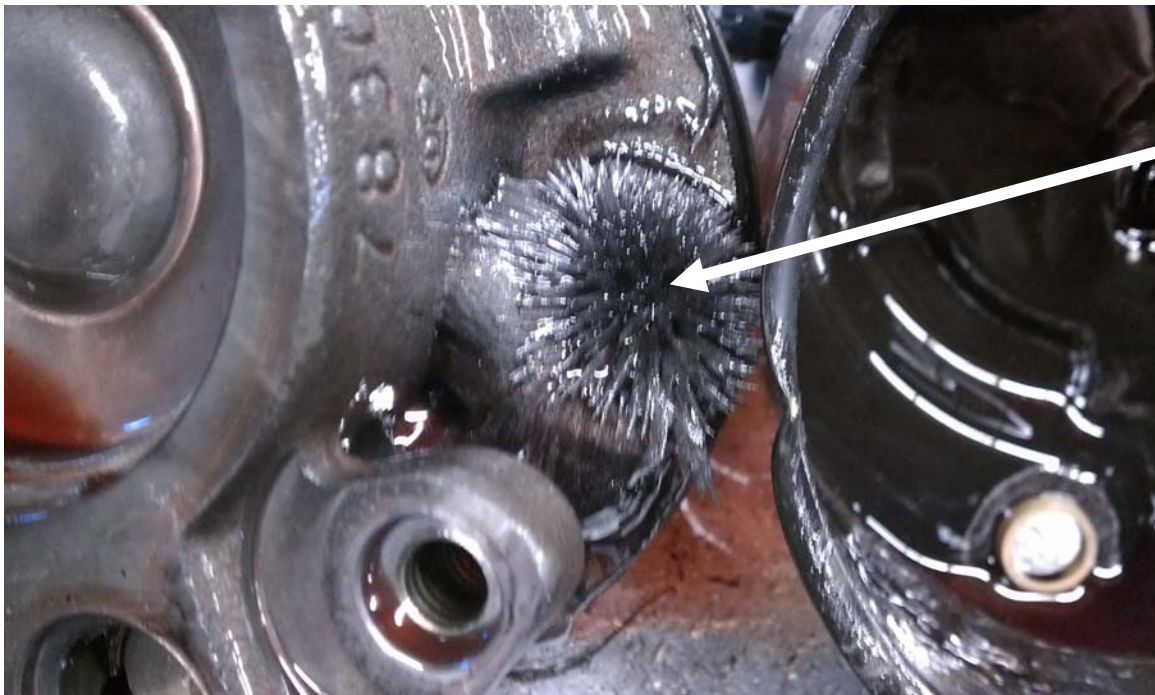
Below is the same pump with Metal Particles left in the system which now covered the magnet and then the excess metal gets into the valve and causes the unit to fail. This failure occurred within a day of the installation of our Pump because the customer did not flush the system.

Metal from old System on Magnet
